USARTL-TR-78-13

REVIEW OF ENGINE/AIRFRAME/DRIVE TRAIN DYNAMIC
INTERFACE DEVELOPMENT PROBLEMS

W. J. Twomey, E. H. Ham
Sikorsky Aircraft
Division of United Technologies Corporation
Stratford, Conn. 06602

June 1978

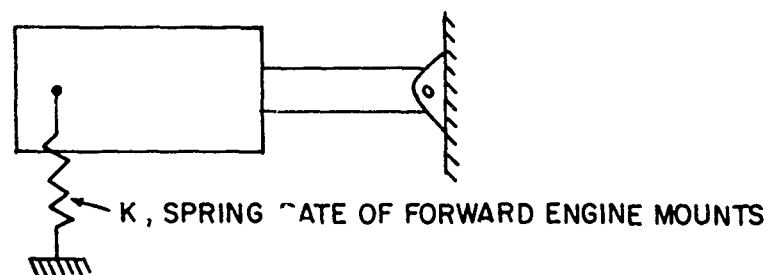
Figure 13. Engine Mode Frequencies vs Spring Rate of Forward Mounts.

The solution was to increase the interface flexibility between the front frame of the engine and the airframe. Figure 12 shows the S-61L engine installation. The "hard" front engine support struts were switched to "soft" elastomeric isolation mounts. This lowered the resonant frequency of the critical first bending mode from 23 Hz to 10 Hz (Figure 13).

The solution also lowered the 2nd engine bending mode frequency so that now it became the primary contributor to the engine response (Figure 13). The result was an engine response still exceeding the original specifications (which were made in terms of local translational accelerations), but which now caused no excess engine bending (i.e., stress) levels, as the original excessive response had done. As a result of this finding, the engine vibratory response specifications were also changed. The maximum allowable translations were raised, but specifications were added limiting the engine flexural bending angle response to typical values known to have been reached on the problem-free SH-3A. Engine bending, not engine translation, was directly related to the critical stress levels in the power turbine bearing housing structure.

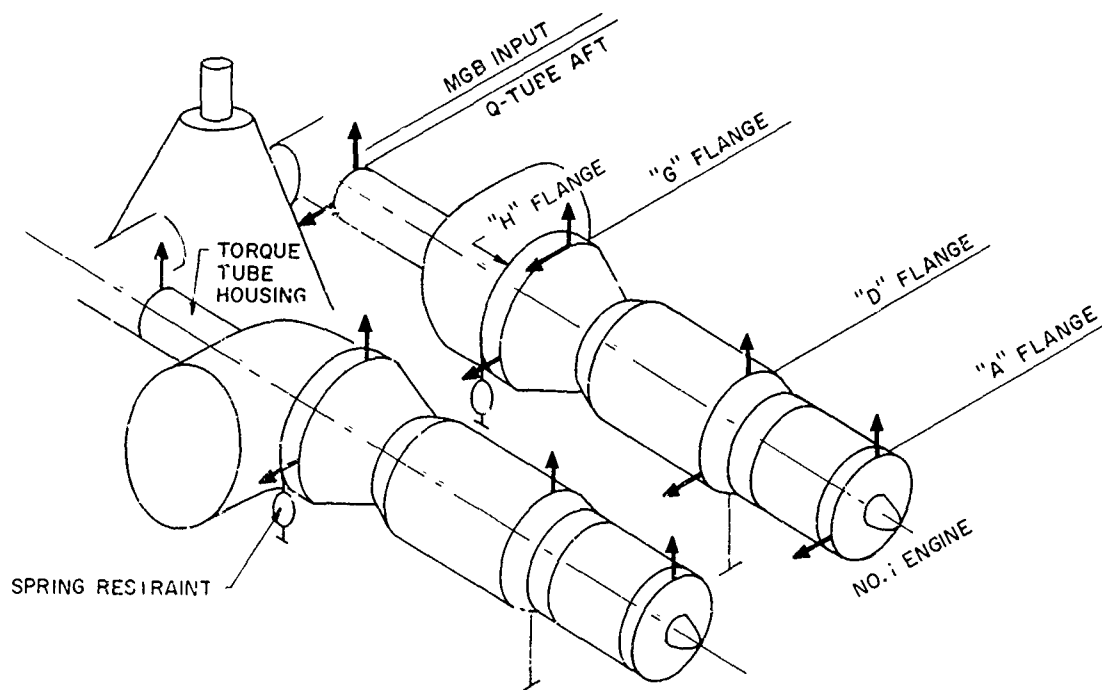
Figure 14. Engine Vibration Pickup Locations.

Flight testing was conducted with vibration pickups on both engines as sketched in Figure 14. Test conditions consisted of the aircraft at 47,000 lb gross weight with forward and aft c.g. locations, engine torque sweeps, flight in hover normal approach to hover, and trim level flights at various speed and RPM settings. Flights were made with engine basic design installations and also with vertical springs installed between the "G" flanges and airframe. Spring rates were varied from approximately 4500 to 10,000 lb/inch, as estimated from engine modal analysis. Testing results indicated that the least amount of engine vibration under approach-to-hover conditions was achieved with a 7700-lb/inch spring installed. Pratt and Whitney engine personnel expressed a preference for the spring to be located at the engine "H" flange. Flight measurements were taken with the 7700-lb/inch spring at the "H" flange, and similar satisfactory results were obtained. Spring installation at the "H" flange on one engine is shown in the photograph (Figure 15). Presented in Figure 16 are engine relative vertical bending mode shapes for the design installation and for the configuration with added 7700-lb/inch spring at the "H" flange.

The solution was to install spring restraints having a vertical spring rate of 7700 lb/inch at the engine "H" flange. Production aircraft were delivered in this configuration and there were no further problems.

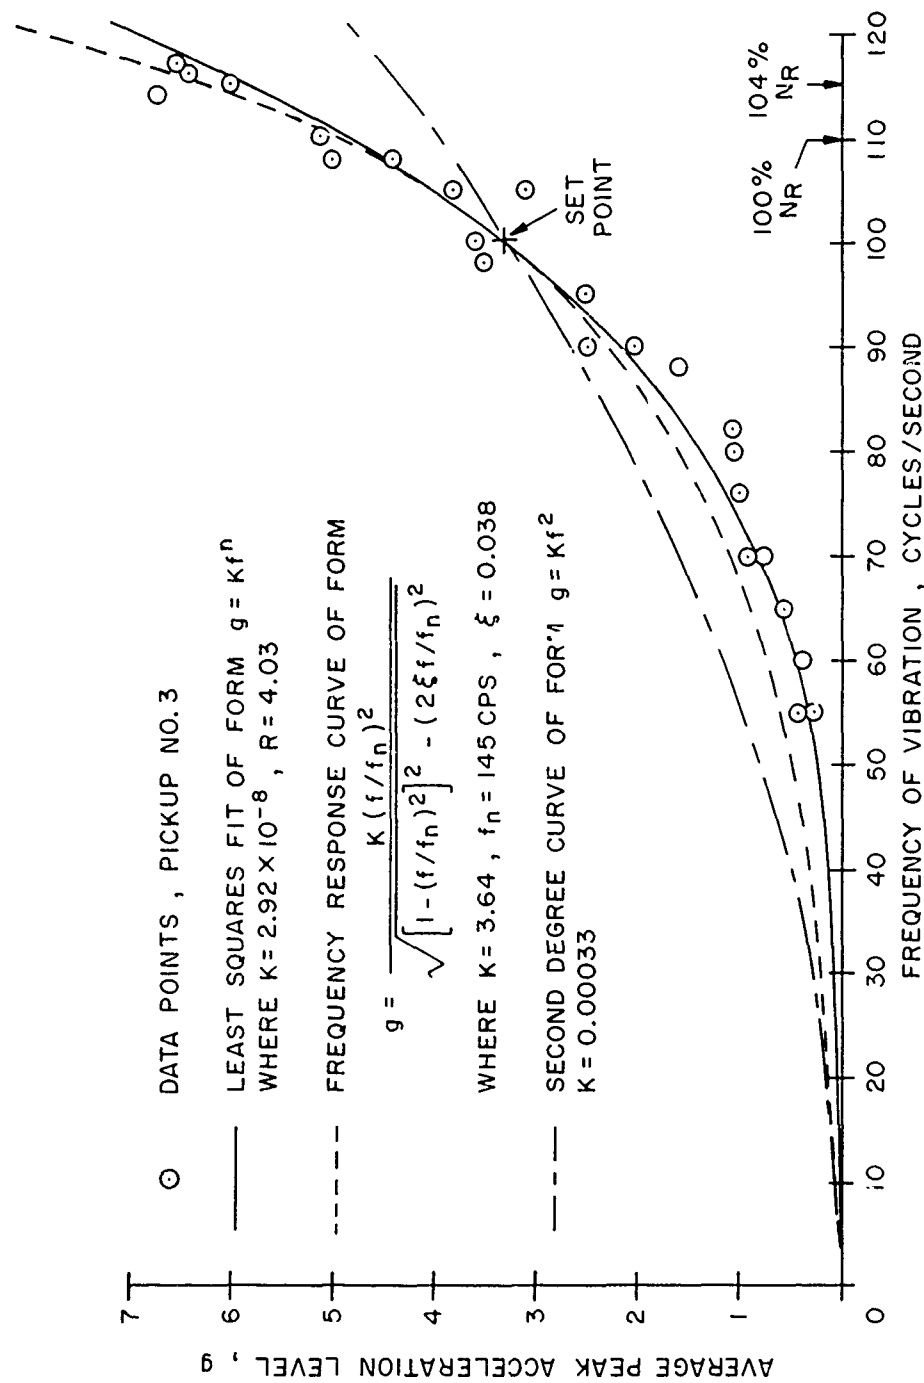
Figure 31. Vibration Response Curves.

In order to determine the nature of the induced vibration in the steel drive shaft installation (i.e., due to simple unbalance or due to operation close to a critical speed), the following analysis was carried out. Data points from the steel drive shaft, pickup 3, are presented in Figure 31. The solid line is an exponential least-squares fit through these data points. If the vibration were induced by a simple unbalance, the amplitude would be proportional to the square of the rotational speed. This "mass unbalance" line is shown in Figure 31 where it is drawn through an arbitrary set point. On the other hand, if the vibration were induced by approaching a critical speed, the curve shape would be that of the classical forced vibration response of a single-degree-of-freedom system which peaks at the resonant frequency. The equation for this curve is shown in Figure 31, where the natural frequency used was 145 Hz and the damping coefficient was 0.038 as measured during the transient response tests. This curve was adjusted to pass through the same set point as the mass unbalance line and is also plotted in Figure 31. The close correlation of the forced response curve to the measured curve indicates that the vibration is more likely to be of the shaft critical type, and the critical speed could occur at 145 Hz (main rotor 133% N_R).

Although the steel engine drive shaft would not be operating near its critical frequency, it was decided to use the aluminum drive shaft because of the lower vibration levels induced in its installation.

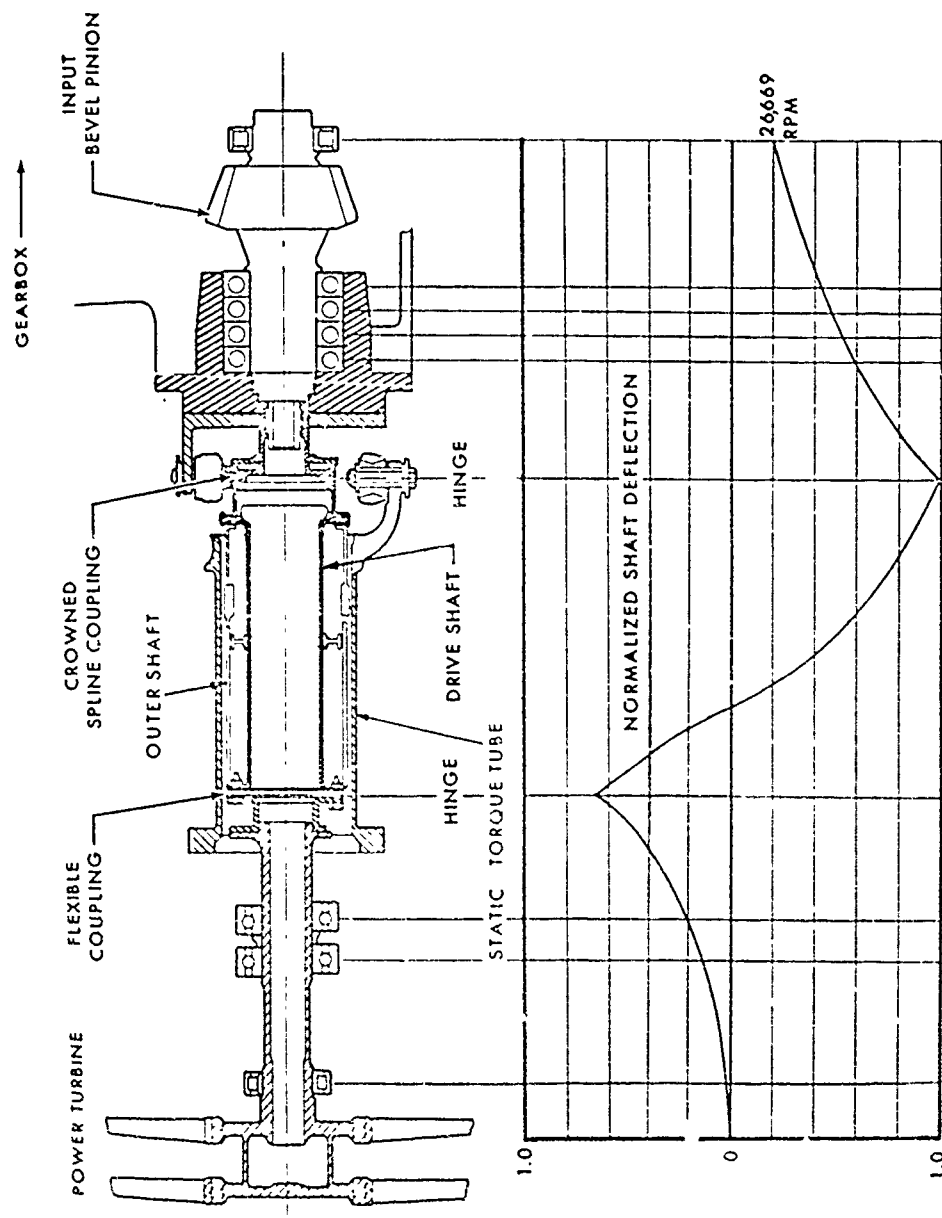
Figure 36. Input Drive Shaft Layout - Critical Speed Analysis.

In the design of the torquemeter/drive shaft assembly, the natural frequency, or critical speed of the assembly, had to be determined to ensure that resonance would not occur within the operating range of 0 to 22,190 rpm, which corresponds to a 117-percent autorotative red-line speed. The critical speeds were determined by computer analysis. The drive shaft outside diameter and wall thickness parameters were varied within the constraints of the torque tube diameter. The drive shaft length, between the flexible steel laminated coupling and crowned spline coupling, was predetermined by the requirement to accommodate the engine exhaust casing. Figure 36 shows the drive shaft layout and the normalized shaft deflection for the first critical speed.

The outer shafts with integral pole pieces were removed from the drive shaft, and roller gearbox development was continued. Further development work on the torque meter system was discontinued.

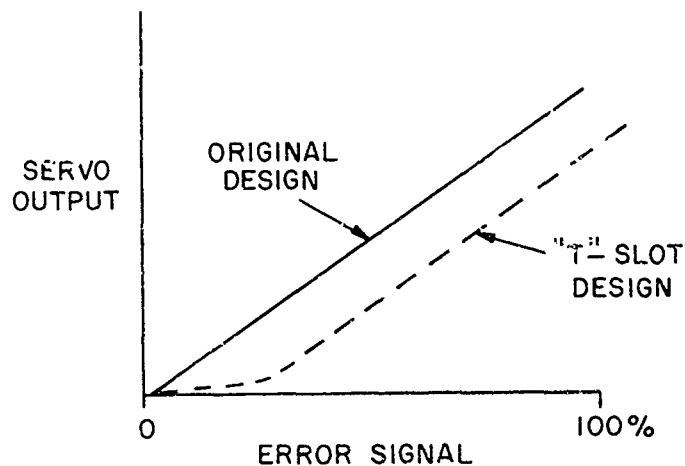
This change made the fuel control unresponsive to the higher frequency (5-15 Hz) inputs but retained fast response for larger step-type inputs.

1. The N₂ governor flex drive cable installation was redesigned to shorten its length and thereby raise its torsional natural frequency.
2. The N₂ governor servo valve was modified to a "T" slot configuration. This modified valve provided a much reduced gain for small error signal inputs but retained high gain for larger error signal inputs, as shown below:

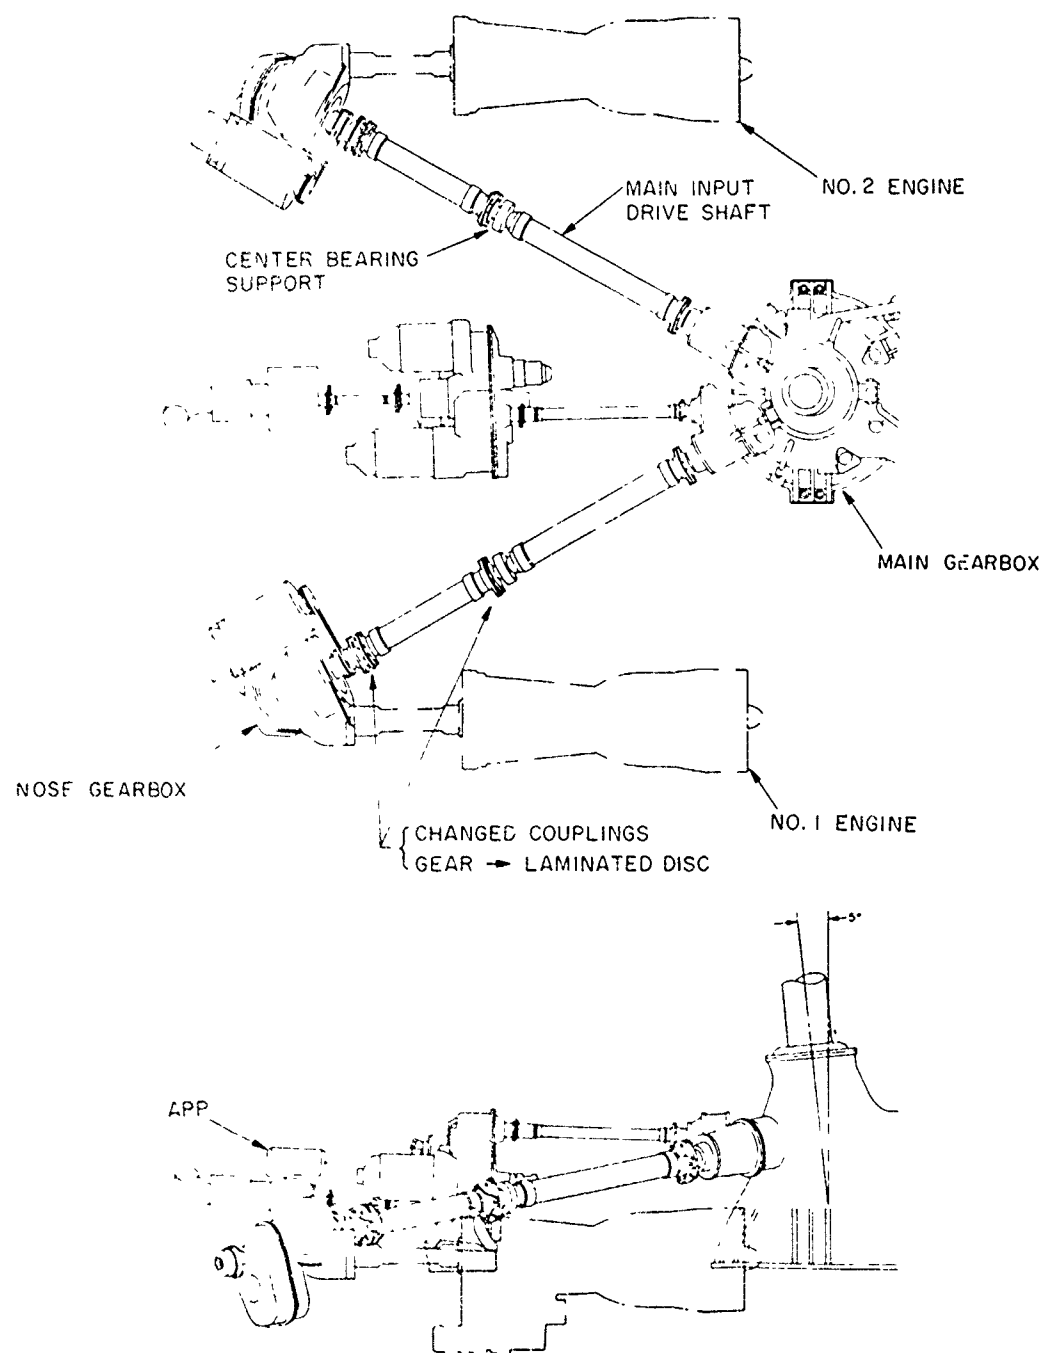
Figure 45. CH-53A Transmission System.

The original design of the main transmission input shaft was of two sections with a viscously damped bearing at the intermediate support (Figure 45). Since the CH-53A engine-nose gearbox combination is mounted on vibration isolators, it was necessary to provide for angular and axial freedom in the shaft. This was accomplished by gear couplings (manufactured by Zurn Industries) on each end of the nose gearbox section of the shaft and a single laminated disk coupling at the main transmission input. The gear couplings have sliding splines which allow adjustment for both shaft length and angular misalignment.

This shortened double laminated disk configuration successfully accumulated 50 hours of the tiedown endurance testing and was installed as the production configuration.

During the testing of the various input drive shaft coupling configurations on the tiedown aircraft, the vibratory stress in the center bearing support strut attachment fittings was monitored. The test results conclusively demonstrated that all of the negligible internal friction couplings (diaphragm, double laminated disk - ball joint, shortened double laminated disk) eliminated the 30 cps vibratory stress. The test results are summarized in Table 4.

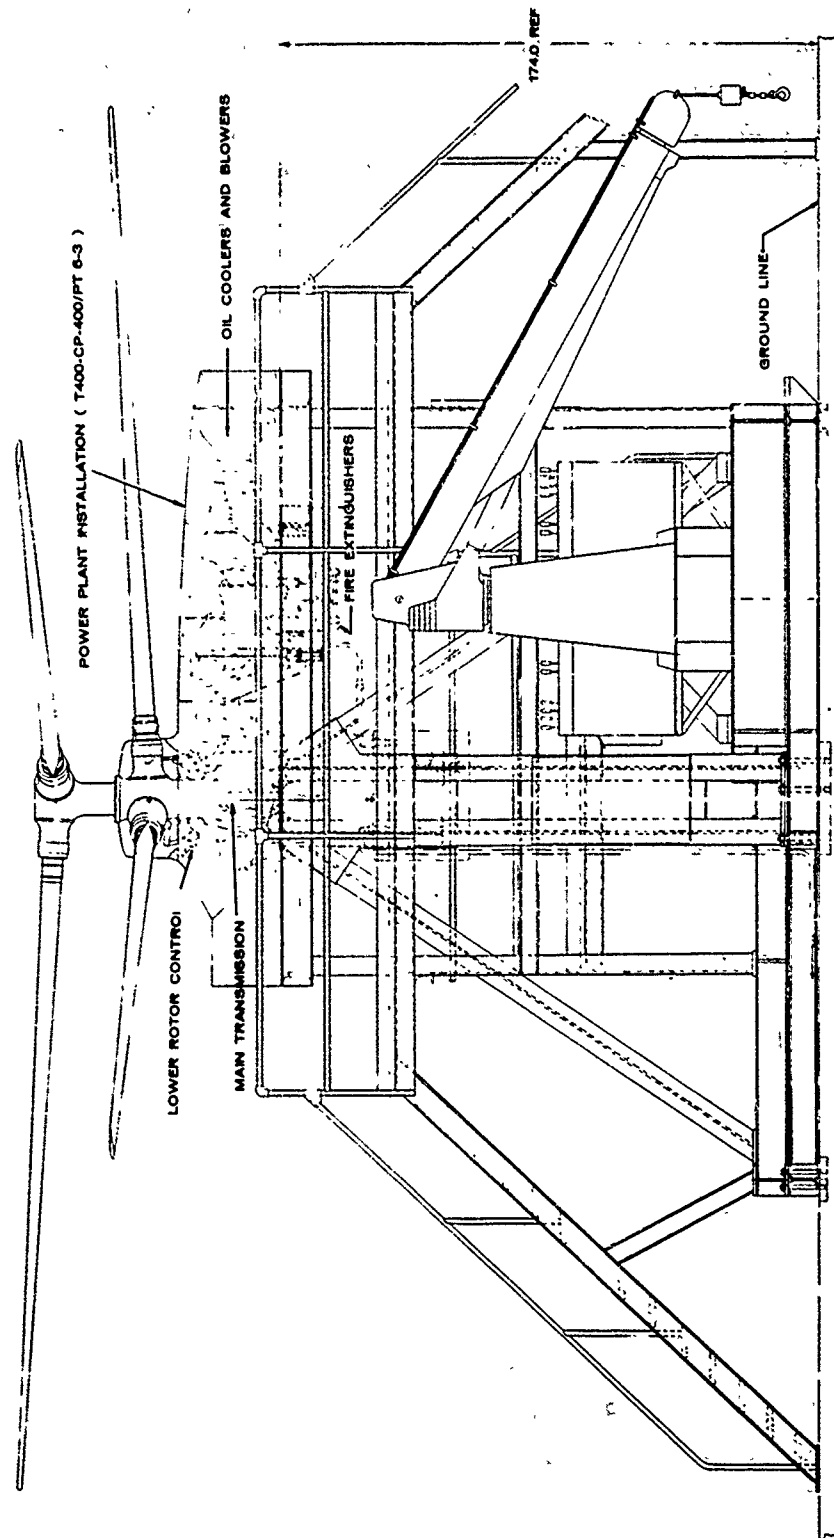
Figure 46. XH-59A Propulsion System Test Stand.

The XH-59A propulsion system consists basically of two contrarotating three-bladed rotors, gearbox, and PT6T-6 engine. This system was undergoing functional and operational tests on the PSTB facility. The test stand configuration is shown in the drawing of Figure 46. In February 1973 an oscillation was discovered which appeared to be a classical hunting stability problem. The oscillations were nondivergent and occurred in the frequency range of $1/3$ to $1/2$ Hz, at approximately 70% N_R . Apparently the usage of too high a governor gain led to the oscillation.

The solution developed for the aircraft and the PSTB was to reduce the governor gain to 9% droop and remove the torque equalizer from the control loop. By special calibration it was possible to bench calibrate governors and controls as matched pairs resulting in small torque splits. This condition eliminated the need for a torque equalizer; however, a differential "beeper" was provided so that the pilot could null out any of the small splits that may have been objectionable.

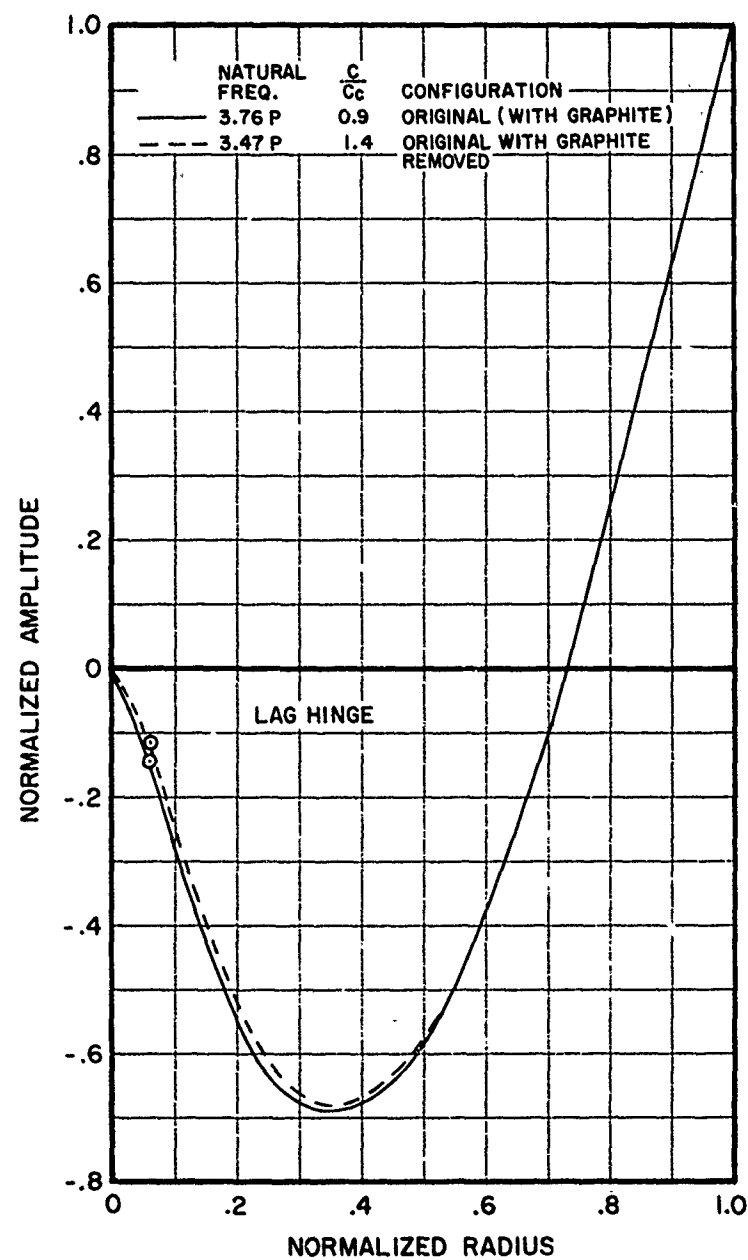
Figure 48. Self-Excited Mode: Detail of Blade Motion.

The 3.6P edgewise mode has very little angular motion across the lag hinge. Therefore, the lag damper is ineffective in providing damping for this mode. The calculated mode shape is shown by the solid line in Figure 48. The hub arm and the root end of the blade move together. The 3.6P mode also has substantial flatwise deflection as shown in Figure 54, which was obtained from the coupled mode analysis. The 2.6P mode, Figure 55, is primarily flatwise. The edgewise motion is relatively small. The curves show modes at a collective pitch of 11 degrees. The modes show less coupling between flatwise and edgewise motion as pitch is decreased.

The oscillation was eliminated by softening the edgewise stiffness of the blades. This decreased the natural frequency of the 3.6P mode and increased the motion across the lag damper in the mode. Figure 48 shows the calculated results. This resulted in a 50% increase in modal damping from the lag damper. The analytical natural frequency went from 3.76P to 3.47P. The test frequency drop, as found from ground tests, was from 3.6P to 3.45P.

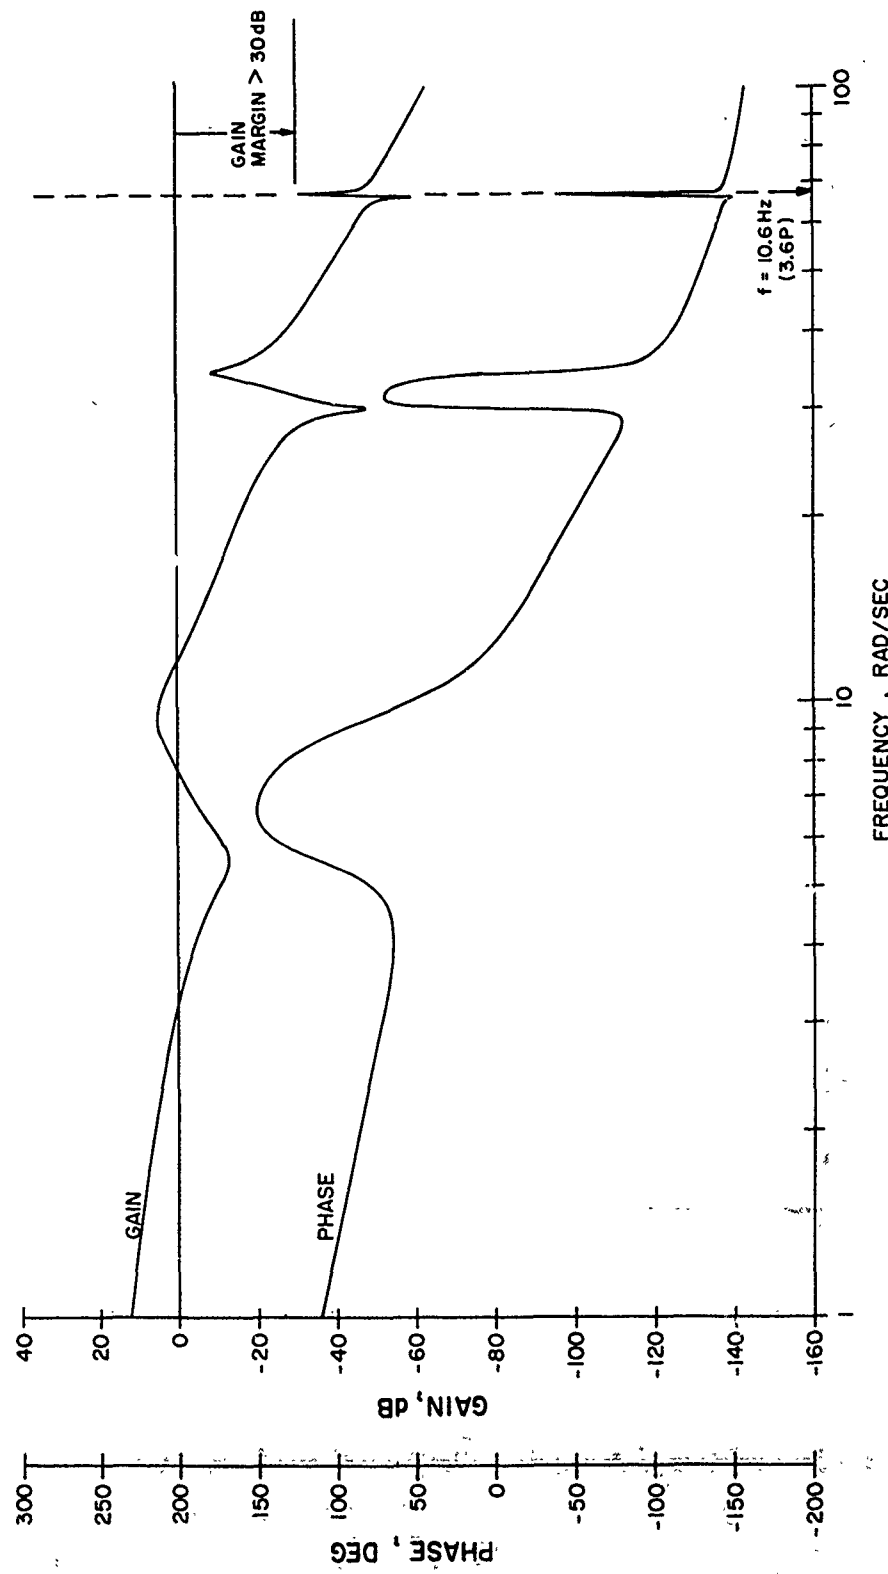
Figure 49. Bode Plot of Rotor/Drive Train/Fuel Control System.

One source of this energy could have been in the fuel control system, as in Problem 17. However, analyses performed by General Electric seemed to rule this out. Figure 49 shows a frequency response plot of the open loop rotor/drive train/fuel control system as calculated by General Electric. The mathematical model used for this analysis was essentially the same as that described in Problem 17 (nine lumped inertias plus the fuel control system), except that the first blade flexural edgewise bending mode was added as a blade bending degree of freedom (Figure 50). As seen in Figure 50 the gain margin is very large (30dB) in the region of 3.6P (66.7 rad/sec), indicating a large margin of stability.

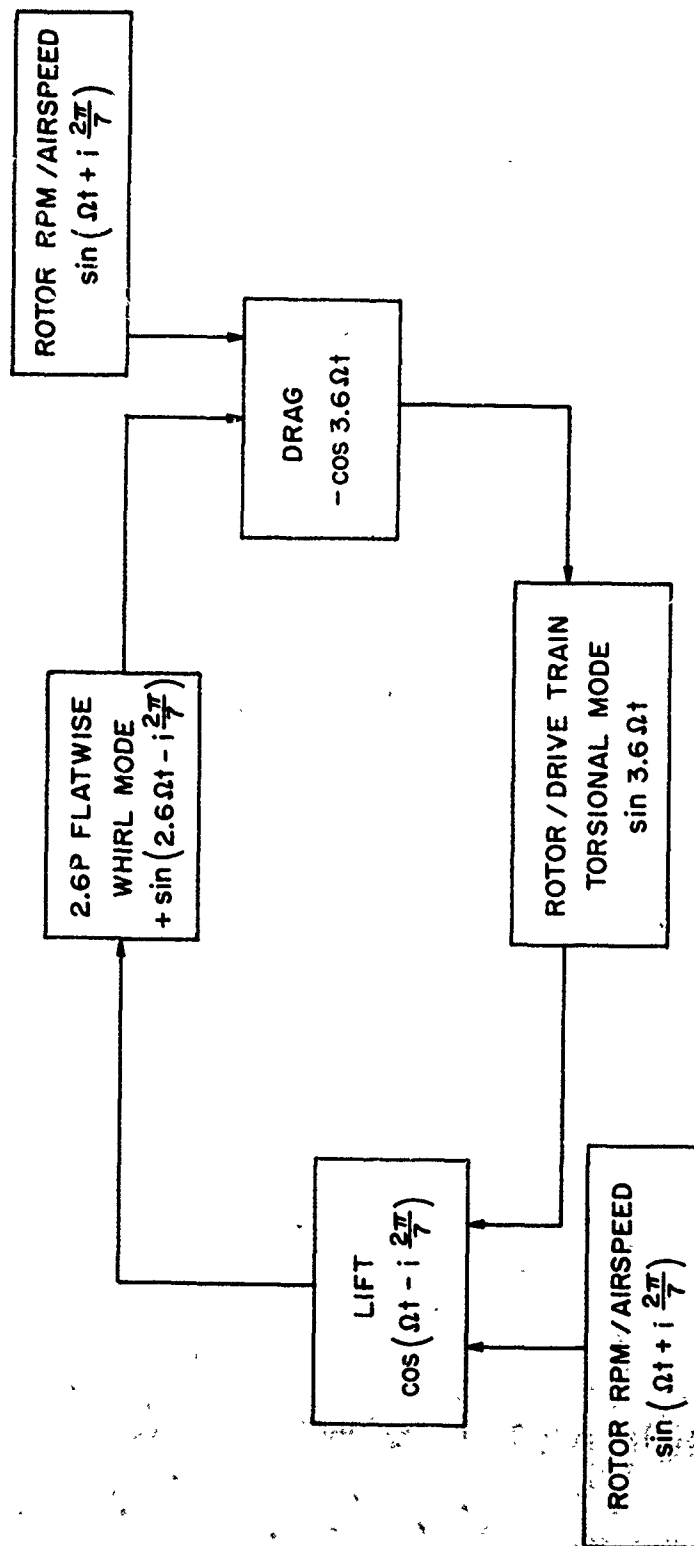
Figure 51. Block Diagram of 3.6P Self-Excitation Mechanism.

The loop which describes the interaction is shown in Figure 51. The 2.6P flatwise mode provides a loading of the 3.6P collective mode. A forward whirl mode has the characteristic that a blade reaches a maximum response later than the blade which follows it. Thus, a wave of peak response is produced which travels around the azimuth at 2.6P in the rotating axis (or 3.6P in fixed axis). This mode produces a torsional windup or pitch change at 2.6P. The pitch change is acted upon at forward speed by a 1P dynamic pressure variation which is of opposite phasing. That is, the dynamic pressure on a blade reaches a maximum value (at azimuth 90°) earlier than on the blade which follows it. The combination of pitch variation and dynamic pressure produces a 3.6P loading which is independent of azimuth angle and is in phase for all blades. This loading produces a response of the 3.6P collective edgewise blade/drive system mode.

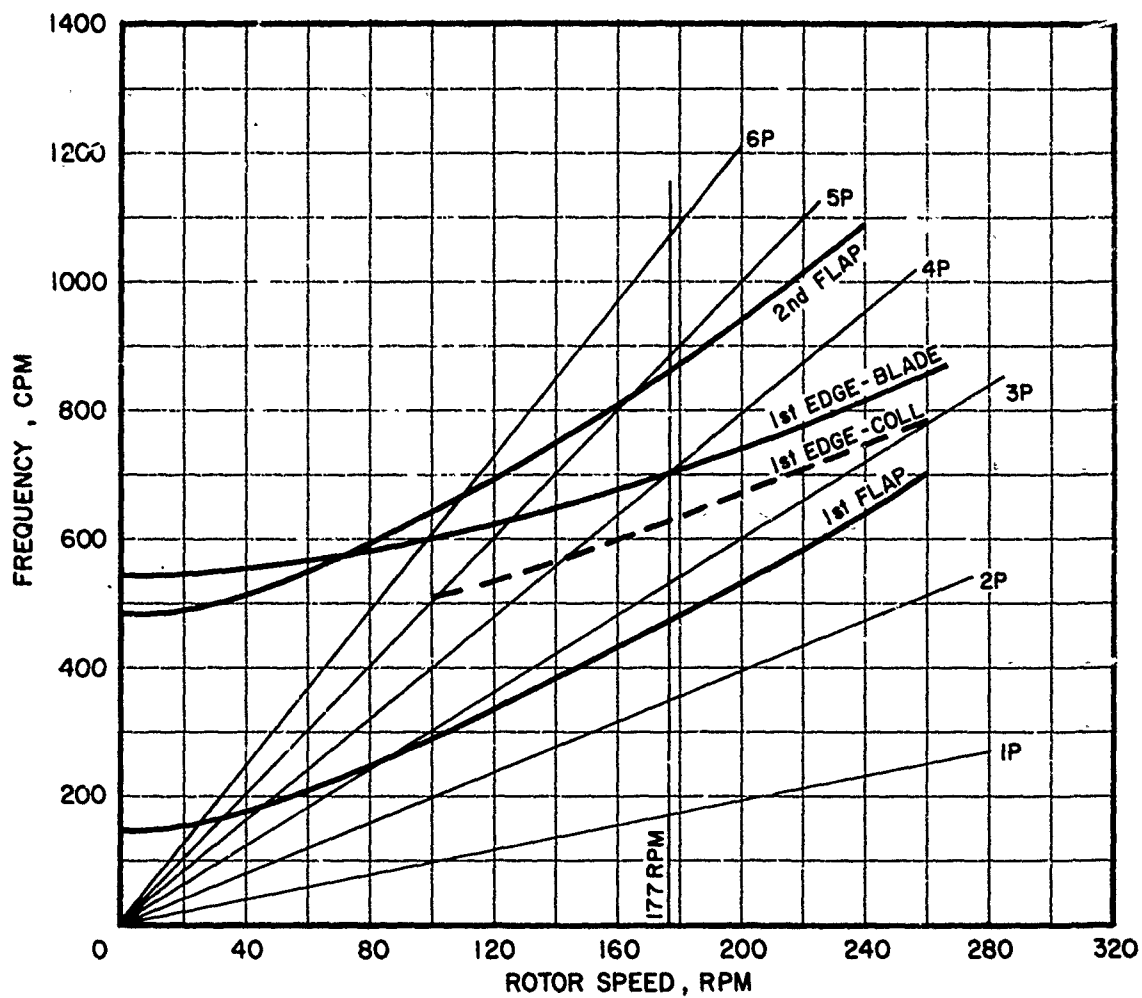
Figure 52. Blade Set Number 4 Natural Frequencies.

Calculations of the main rotor blade modes for blade set number 4, which were the blades on the aircraft when 3.6P oscillation was encountered, gave a first flatwise bending mode at 2.7P and a first edgewise bending mode at 4.05P as shown in Figure 52. The seven blades acting collectively (in phase) edgewise combine with the torsional dynamics of the drive train (engines, shafts, transmission) to give a combined rotor drive train mode at 3.76P analytically. This is shown in Figure 53. This figure shows the impedance of the drive train at the rotor hub for the range of frequencies up to 6P (shown in solid) and the natural frequency of the edgewise rotor mode acting against varying hub impedance values (shown as a dashed line). The intersection of the two curves occurs at the natural frequency of the combined rotor/drive train mode.

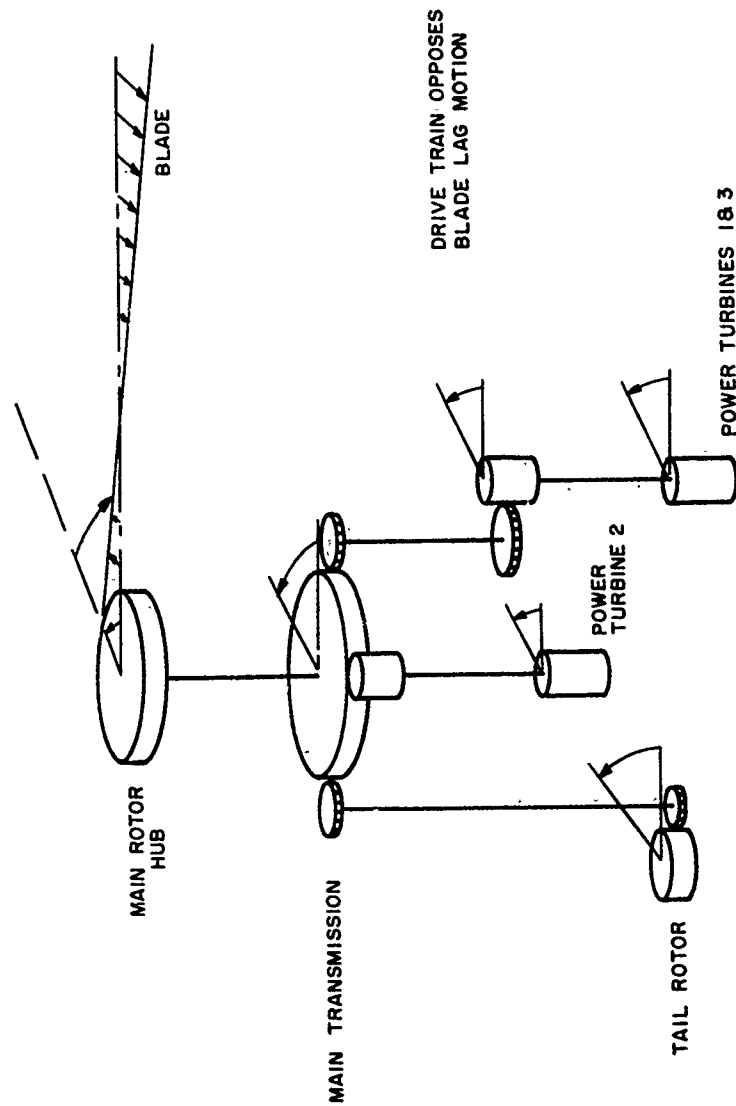
Figure 56. Self-Excited Mode: 1st Torsional Mode of Rotor/Drive System.

Subsequent analysis and testing showed that the oscillation was a closed loop feedback self-excited oscillation of the collective rotor/drive train/engine/fuel control torsional system. The oscillating mode was the first (nonzero) natural mode of the elasto-mechanical system. In this mode the main rotor blades lag together against the drive train and engines, the only node line occurring on the blades outboard of the lead-lag hinges (Figure 56).

The oscillation was caused by the high gain of the hydromechanical fuel control (rotor speed governor) system feeding energy into the first torsional mode. In this mode the principal dissipation of energy occurs in the blade lag dampers. The effectiveness of these dampers decreases with aircraft forward speed due to the increased presence of superimposed n/rev steady-state motions in the dampers. Eventually a speed is reached at which the damping available is insufficient to dissipate the energy input from the fuel control system. On the CH-53E, this onset of oscillation occurred at different aircraft forward speeds depending on rotor RPM and aircraft gross weight and c.g. position.

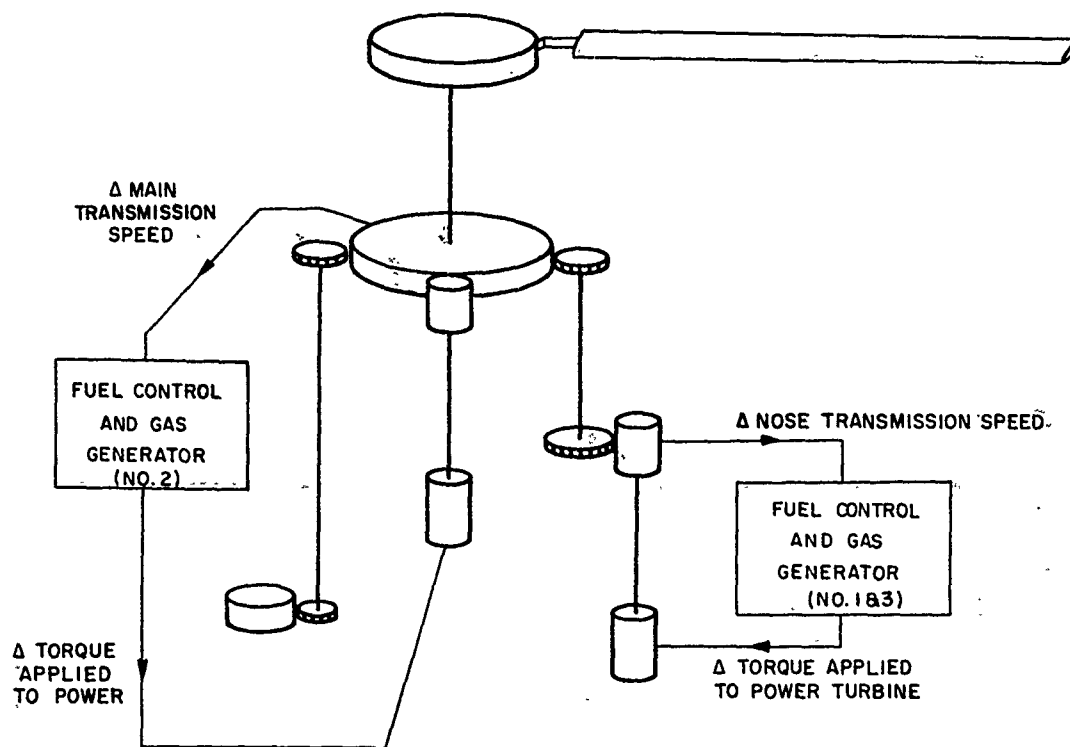
Figure 57. Rotor/Drive System Analytical Model Schematic.

The analytical model used to represent the rotor/drive system was formulated as a 7-mass torsional model (Figure 57). The model had engines 1 and 3 lumped together, and included the rigid blade centrifugal stiffness. The lag damper was represented as a linearized viscous damper. The hydromechanical fuel control/gas generator systems are shown as boxes in Figure 57. A decrease in drive train speed (sensed at the nose gearbox by engines 1 and 3 and at the main gearbox by engine 2) is sensed by the system and results in an increased engine torque being applied (via changes in fuel flow and gas generator speed) to the power turbines.

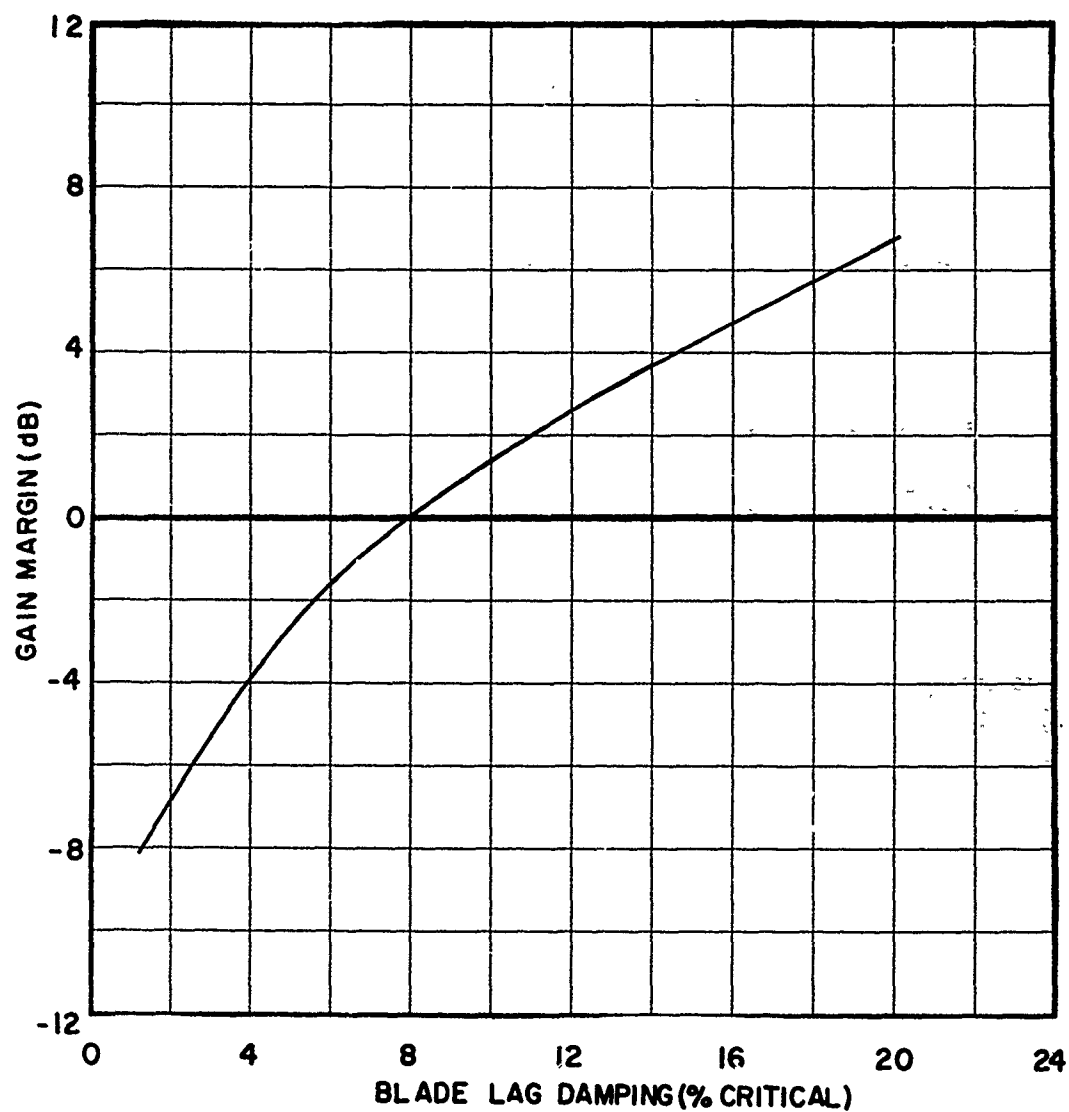
Figure 58. Gain Margin of Torsional Mode vs Blade Lag Damping.

Analysis showed that the stability margin was sensitive to blade lag damper values (Figure 58). An extensive test and analytical effort was therefore undertaken to determine just how much damping the lag damper was providing to the critical mode.

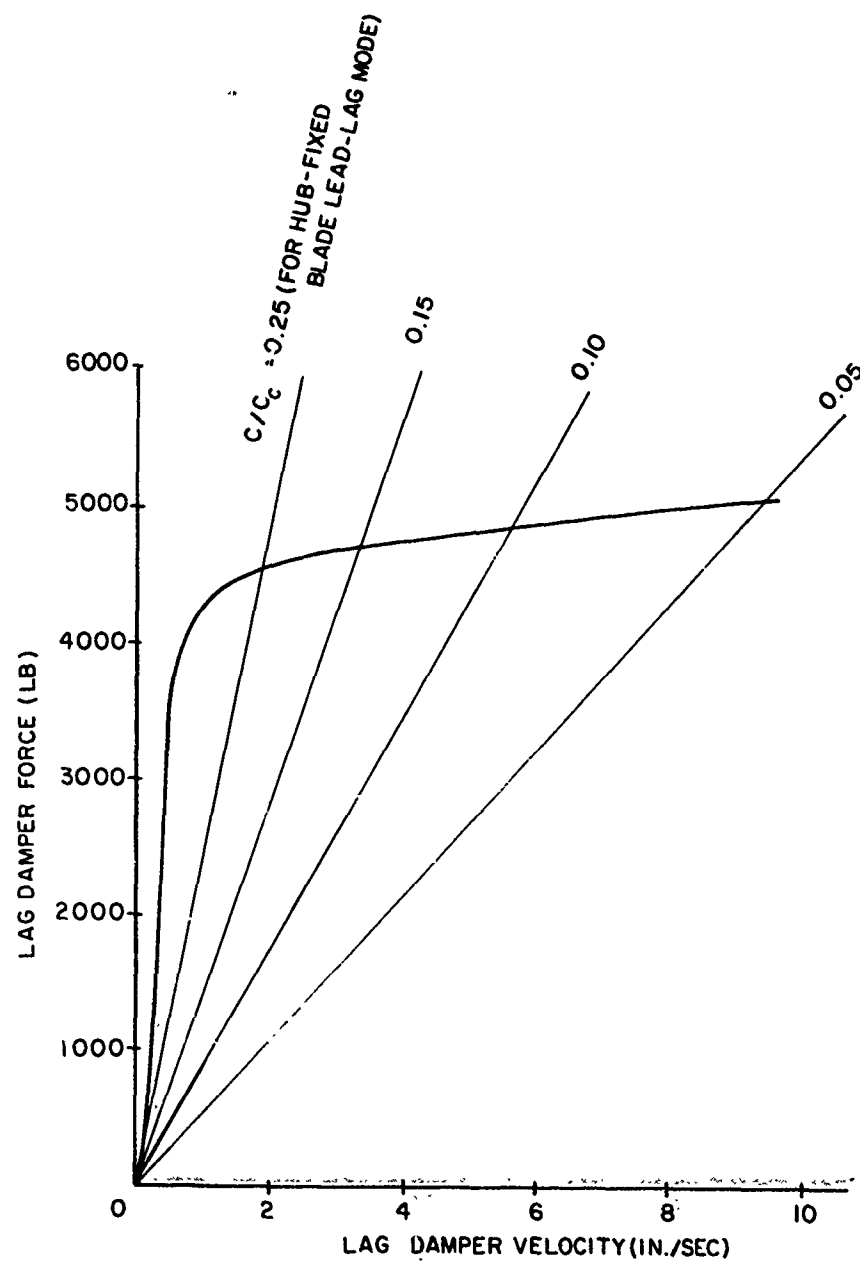
Figure 59. Lag Damper Instantaneous Force-Velocity Relationship.

The instantaneous force-velocity relationship for the damper is given in Figure 59. In this damper an orifice-type damping force, proportional to the velocity squared, is present up to the "breakout point", at which a preloaded relief valve opens (at a velocity of 0.8 in/sec) and the damping derivative suddenly becomes very much smaller. The effectiveness of such a damper is diminished by the presence of steady-state harmonic (n/rev) lag motions, as seen from bench test data plotted in Figure 60. These motions, which become larger with increasing airspeed (Figure 61), cause the damper relief valve to remain open for increasing portions of the cycle. The resulting loss in damping is shown in Figure 62. Eventually a speed is reached at which the damping available is insufficient to dissipate the energy input from the fuel control system and the overall gain margin goes to zero (Figure 63).

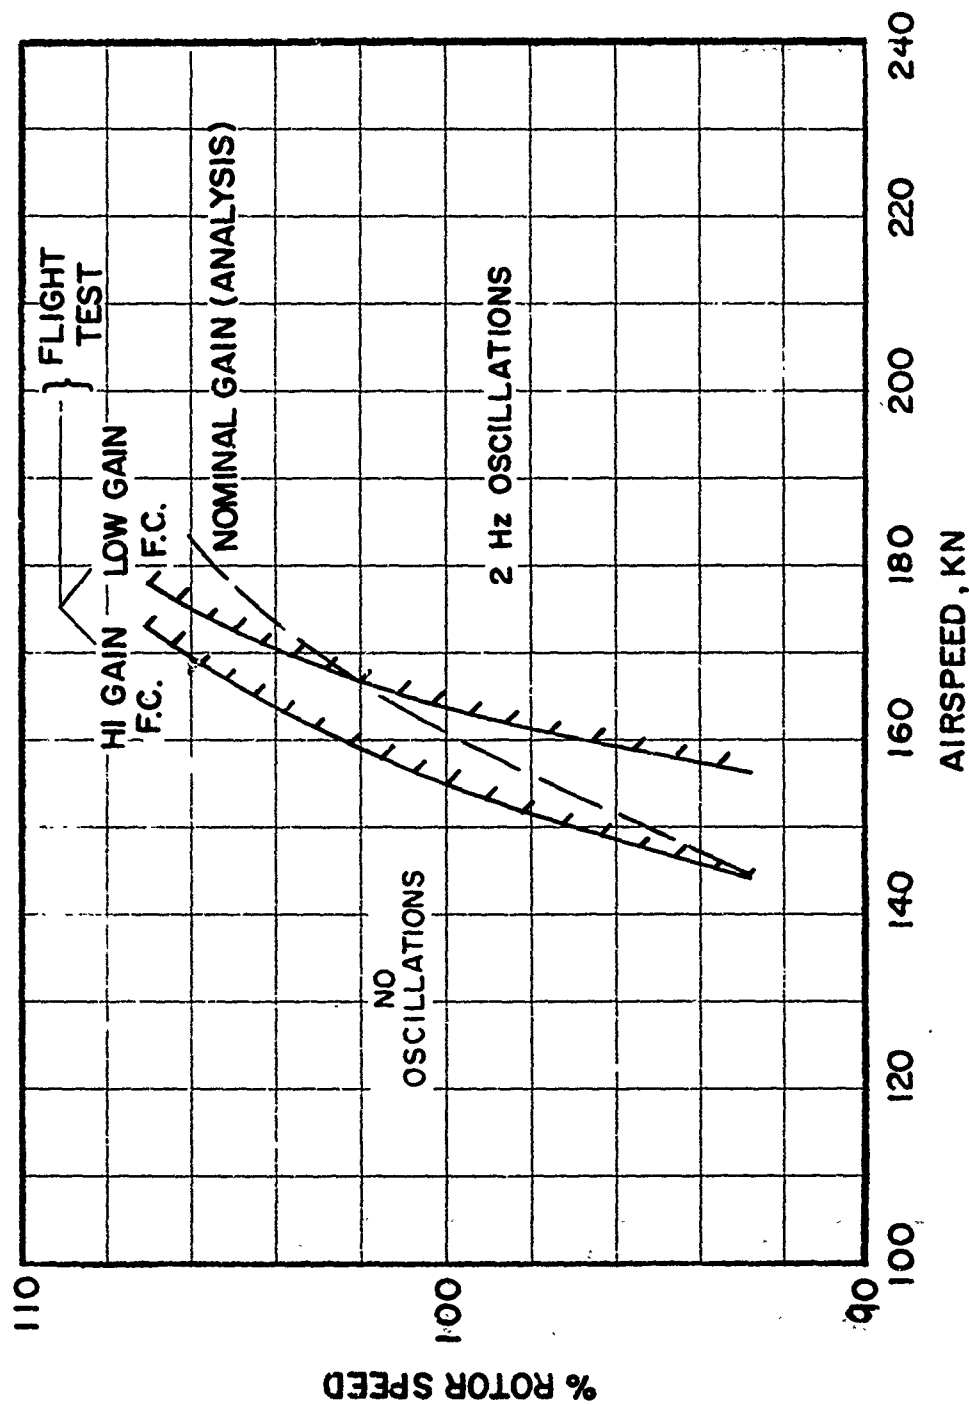
Figure 64. Oscillation Boundaries of Torsional Mode.

Decreasing the gain of the fuel control system was first shown to be effective in increasing stability when flight test results of aircraft having fuel control gains on the high and low sides of manufacturing tolerances were compared (Figure 64). Analysis showed that the fuel control gain was most sensitive to:
